Monitoring Data Record

Project Title: <u>R-2248D – Charlotte Outer Loop</u>	COE Action ID: <u>200131321</u>
Stream Name: <u>Trib. to Dixon Branch (Site 16)</u>	DWQ Number: <u>011231</u>
City, County and other Location Information: <u>Mecklenburg County, Charlotte Outer Loop, R-2248D Right of Project Station 13+50 Ramp 2D</u>	
Date Construction Completed: <u>February 2005</u>	Monitoring Year: (<u>3</u>) of <u>5</u>
Ecoregion: _____	8 digit HUC unit <u>03050103</u>
USGS Quad Name and Coordinates: _____

UT to Dixon Branch

Year 3 Summer – September 2011

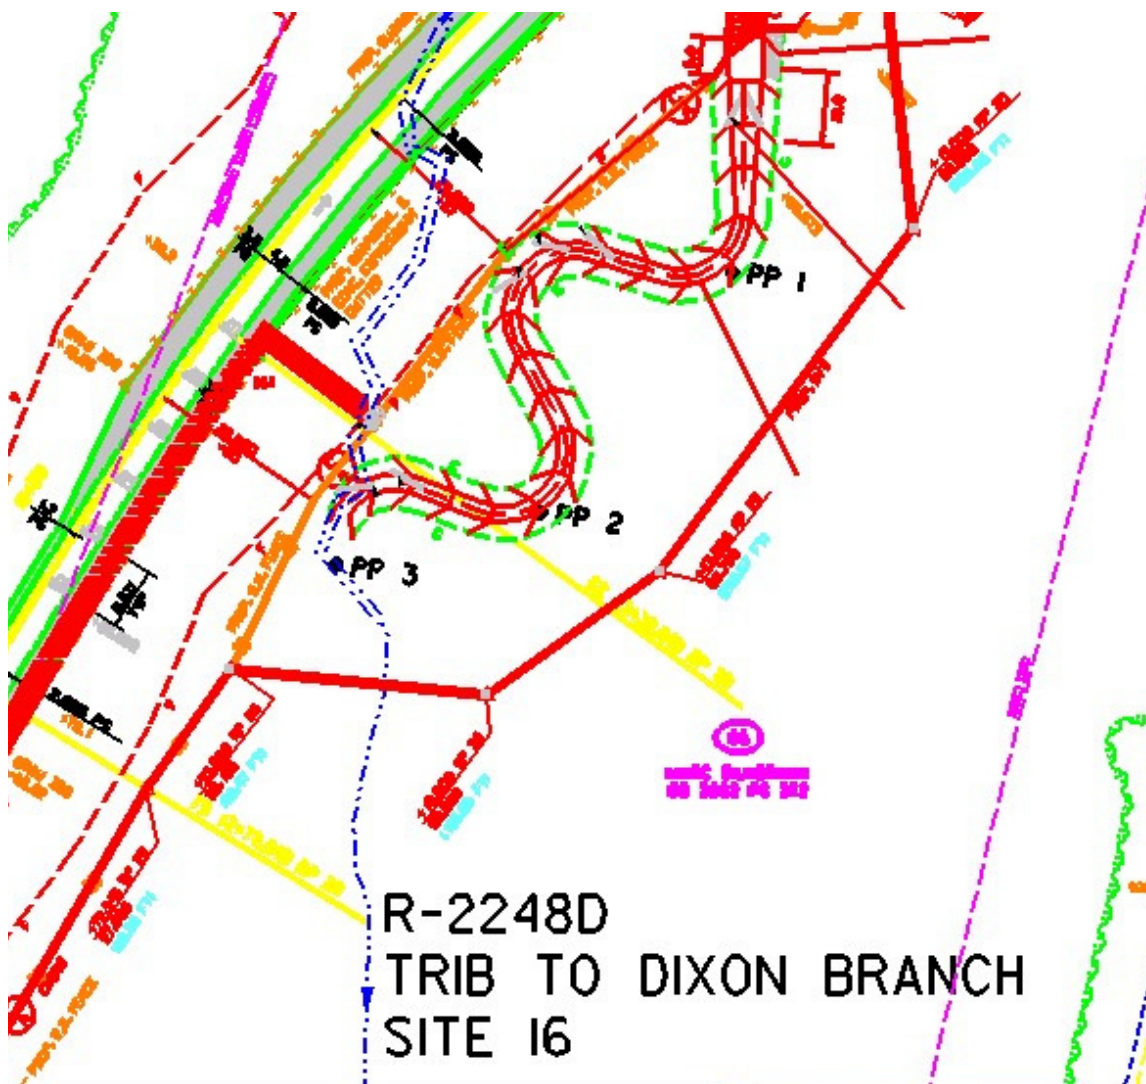
Log Sill #4 (looking upstream)

Date 9/12/11	Between PP#1 and PP#2	Station Number	Station Number	Station Number	Station Number
Structure Type	Log Sills				
Is water piping through or around structure?	Water is piping under or around three of the four installed log sills				
Head cut or down cut present?					
Bank or scour erosion present?					
Other problems noted?
